**Additional acetic acid salt spray test (test results after 1500 and 2000 hours)**

<b>Contact Person:</b>	<b>Verdonckt Cis</b>
<b>Company:</b>	<b>TÜV AUSTRIA Belgium nv</b>
<b>Address:</b>	<b>Wingepark 41 B - 3110 Rotselaar</b>
<b>Tel.:</b>	<b>+32 16 39 60 00</b>
<b>Our Reference:</b>	<b>TABE-2025-ML-00860-B-ENG</b>
<b>Date:</b>	<b>30/01/2026</b>

This report presents the results of an additional acetic acid salt spray test, performed on test samples that were previously tested during 1000 hours (see report TABE-2025-ML-00860-A). The test time was prolonged to a total test time of 2000 hours.

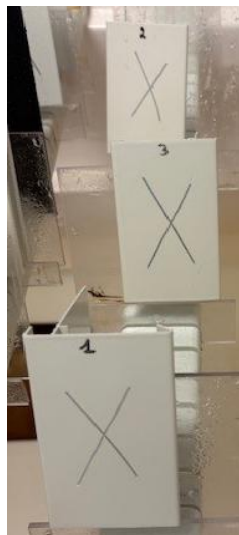
Figure : Exposed samples in climate chamber

Pretreatment of the samples : Exposed in the received condition		
Application of a scratch : 1 X-cut scratch on each sample (L: 2x10cm, w: 1mm, cfr. QC)		
Relevant test surface : Plate surface, excl. edges		
Angle of exposure : 15-25° vs. vertical line		
Test program : Specific		
Sample treatment : Samples are not rinsed for intermediate evaluations		
Time of evaluation : After 1500 & 2000 hours

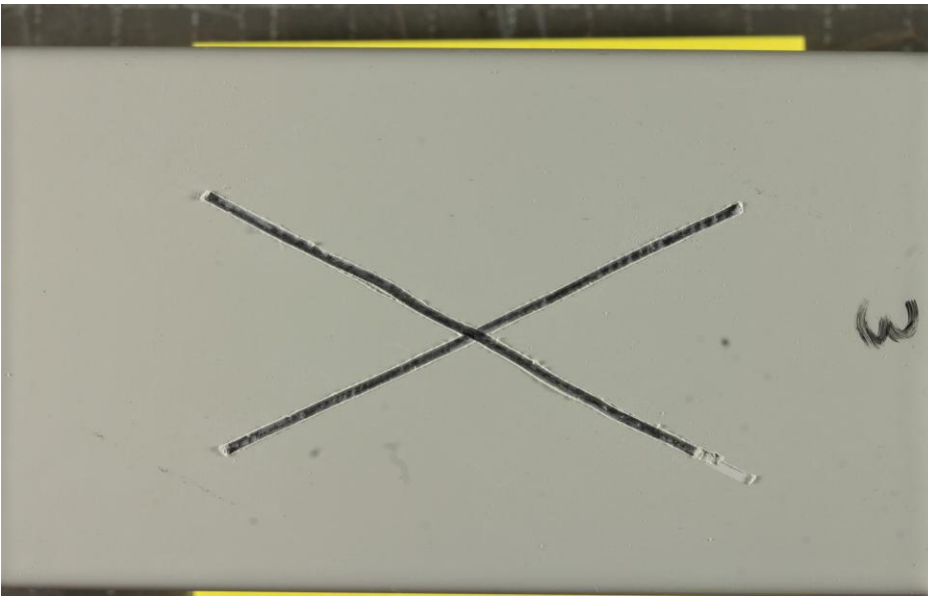
Fig. 3 - Sample 3 - Initial condition of the received samples (incl. scratch)

Sample type name	Sample code	Dry film thickness (µm)		
		Average	St. Dev.	
QC Seaside	1	190	17	Fig. 1
PreDura	2	201	5	Fig. 2
PréAno	3	257	7	Fig. 3

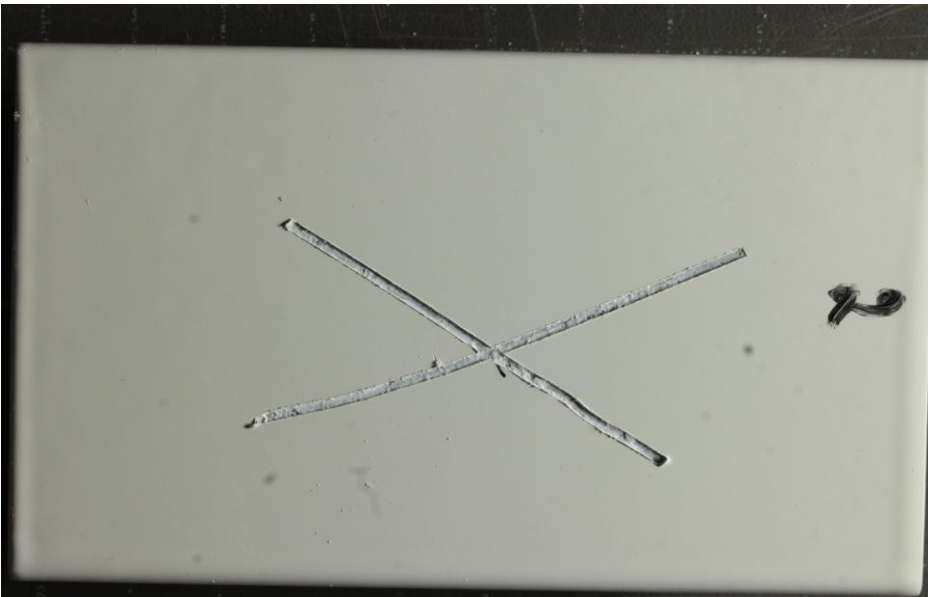
Fig. 10 - Sample 2 - Condition after 2000h AASS test

Sample type name	Sample code	Blistering acc. to ISO 4628-2 (max. 0(S0))	Max. infiltration length (mm), rounded to nearest 0.5 mm	Evaluation for max. infiltration ( $\leq 3$ mm)	Infiltrated surface area (mm <sup>2</sup> )	Total scratch length (cm)	Infiltrated surface area (mm <sup>2</sup> /10cm)	Evaluation for infiltrated surface ( $\leq 16$ mm <sup>2</sup> )	Rating acc. to Qualicoat spec. (per sample)	Figure Ref.
QC Seaside	1	0	2.5	Pass	28	11	27	Fail	Fail	Fig. 8, 9
PreDura	2	0	1.0	Pass	1	10	1	Pass	Pass	Fig. 10
PréAno	3	0	0.0	Pass	0	12	0	Pass	Pass	Fig. 11
